Story of the founding of the Matsumoto Sabo Work Office and history of its work

Sabo Technology for disaster prevention in harmony with nature

~Various Sabo facilities~ All three major rivers including Azusa River, Takase River and Himekawa River under the jurisdiction of Matshmoto Sabo Control Office have their stream sources in the North Japan Alps and flows into the Japan Sea. Matsumoto Sabo Work Office covers a wide range of areas from the upper torrents toward the midstream and takes diversified measures according to the characteristics of each section of the streams, actively working on the construction of a variety of

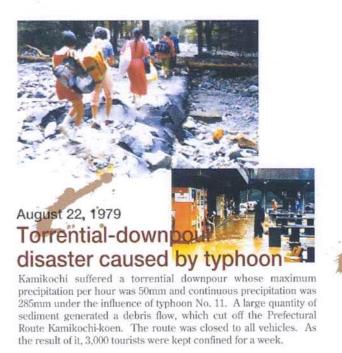
lowed out from the upper reaches broke the embanks on both sides of the main Nakawa River. The public facilities and the houses were washed away, and the route was cut off. The Village was isolated from the outside. The amount of damage reached 5.6 billion yen. Deluge of the Himekawa River caused by torrential downpour during last stage of the rainy season season, and a heavy rain fell that recorded the total precipitation of 400mm locally. The surface of a mountain collapsed all over the drainage areas of the Himekawa River. A debris flow occurred in 38 locations of the Himekawa River system, which cut off the route. Four hundred and twenty-five households in 19 villages became isolated from the outside. Service on the JR Oito Line was suspended over a long period, too. Moreover, the sediment flowed into the Honkawa River from its branches, and became accumulated. For this reason, the river bed rose by more than 10m at the location that was hit hardest.

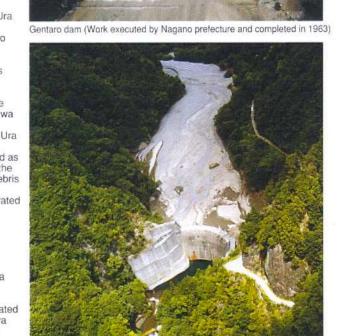
Shimashimadani No. 3 sabo dam (completed in 1978)

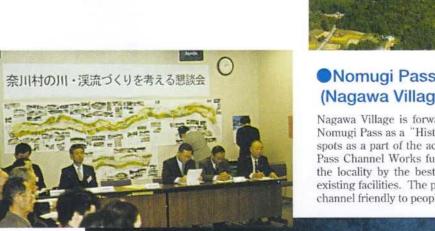
Nomugi Pass Channel Works (Nagawa Village, Nagano Prefecture) Nagawa Village is forwarding a plan to designate the area around Nomugi Pass as a "History Zone" for walking in nature and historic spots as a part of the activation plan of local communities. Nomugi Pass Channel Works function as the core of this project, reflecting the locality by the best use of natural beauty rich with water and existing facilities. The project is in progress under the slogan "Sabo hannel friendly to people and nature"

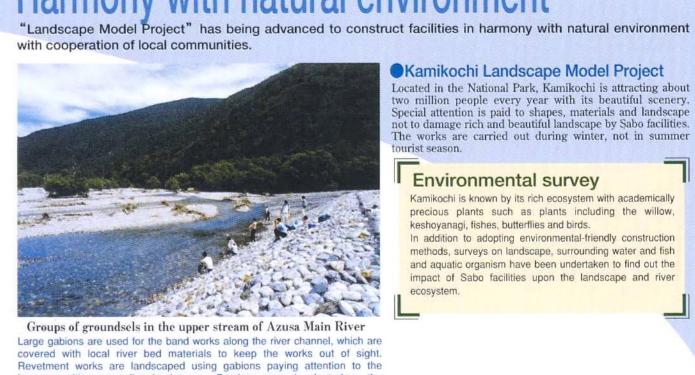
harmony with surrounding landscape. Bamboo grass is planted on the mounding on the back of the revetment. Trees are left uncut as much as practical to preserve and promote greening of the area.

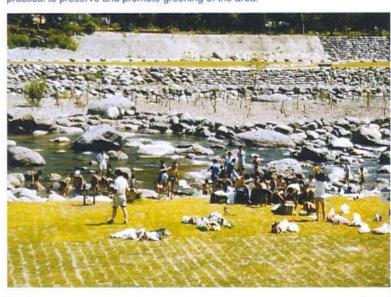
Transplantation of endangered species a Chinese milk vetch, "Tsumerenge In an effort to reduce the impact of the grounds works upon the local vegetation, an indigenous species, Tsumerenge growing along Matsukawa River was transplanted to the upper stream under the guidance of local specialists. Tsumerenge designated as an endangered species in the red data book by The Nature Conservation Society of Japan. Kurotsubame Corbicula, also designated as an endangered wild creature in the red data book by Environmental Agency.
