# TATEYAMA SABO

In an Attempt to Improve the River Jogajji,  
a Frequently Flooding Mountain Torrent,  
into a Placid River Causing no Disaster.

Tateyama Sabo Work Office  
Hokuriku Regional Costruction Bureau,  
Ministry of Construction

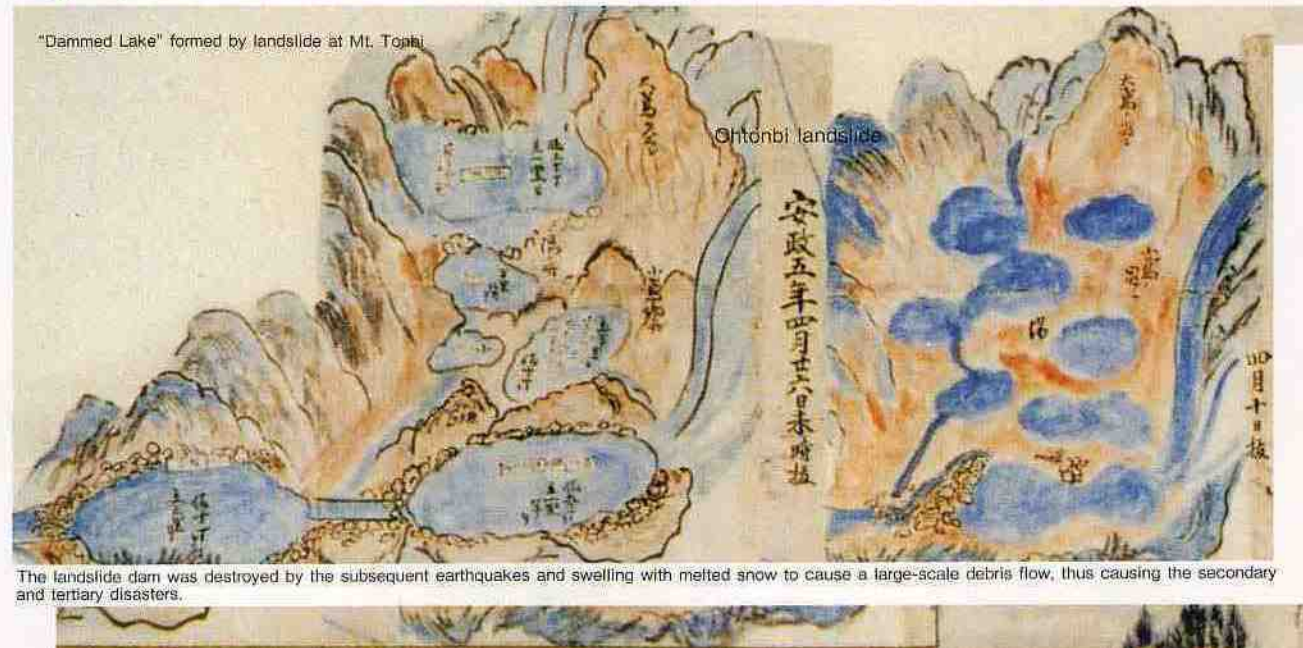
The landslide dam was destroyed by the subsequent earthquakes and swelling with melted snow to cause a large-scale debris flow, thus causing the secondary and tertiary disasters.

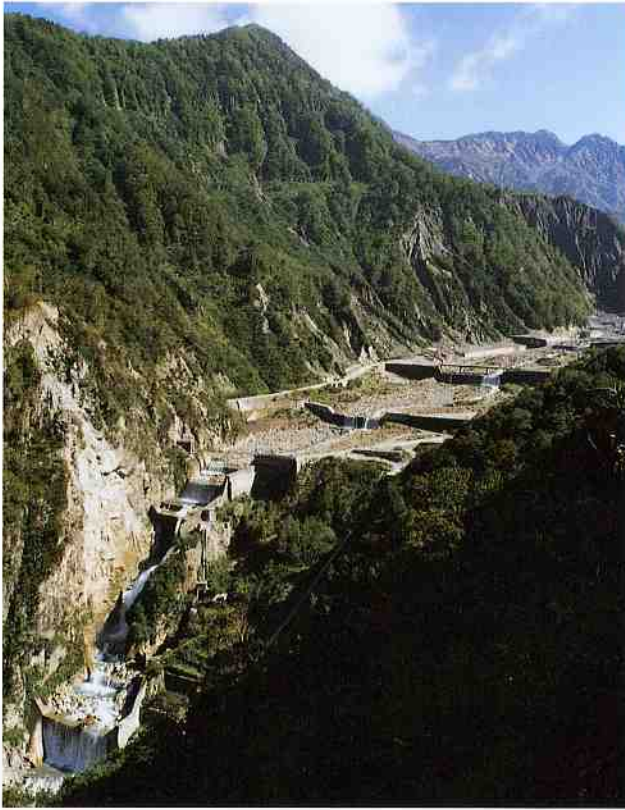
◆The Shiraiwa Sabodam was brought to completion in 1939 after the start of its construction in 1931 as a Sabodam for checking up a vast volume of sediment flowing out from the Tateyama Caldera. It is the largest scale in Japan, being 63.0 m in dam height, thus deserving the name of a leading role in the Tateyama Sabo Work.

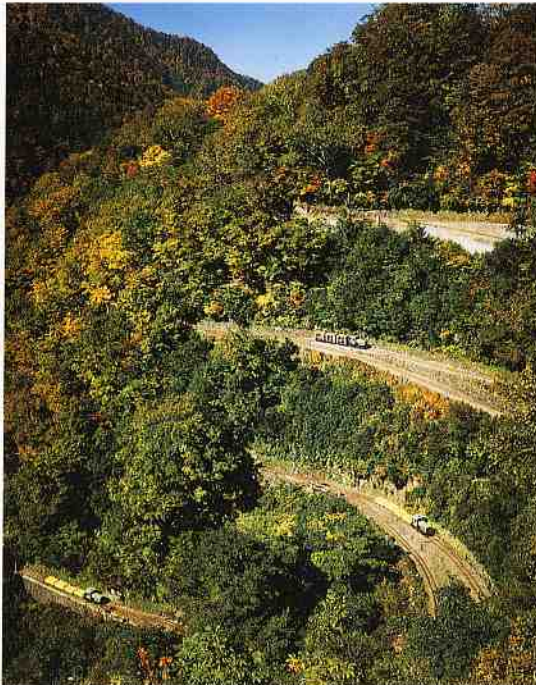
◆The service train (Special Track for Sabo Work) is used for transportation of construction materials from the Tateyama Sabo Work Office to the basin of the Yukawa. It is a unique facility peculiar to the Tateyama Sabo Work in which a switchback system is employed as a rare case in the narrow gauge of 610 mm. Especially the 18-stage switchback system at Kanbadaira is of the largest scale in Japan, capable of going up the slope of 200 m in elevation at a dash.

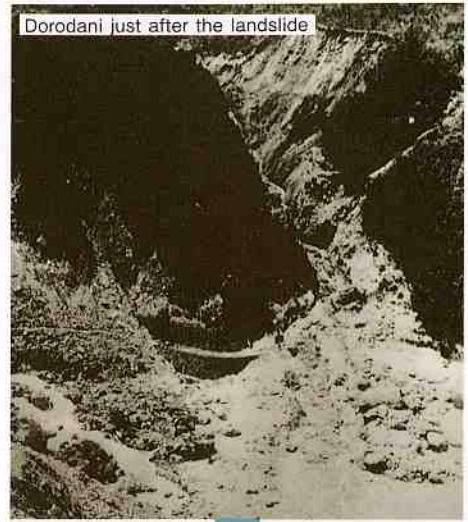
Dorodani just after the landslide

◆In order to prevent the re-erosion of the Dashiwara Plain, the Dorodani Sabodam Group was brought to completion in 1938 as a group of stepped concrete dams combined with hillside works. This is a famous dam group to be recorded along with the Shiraiwa Sabodam in the Japanese Sabo Work history. Thanks to the Sabo work, Dorodani is now restored to its original condition and covered with green to the extent that no traces of landslide may be found.

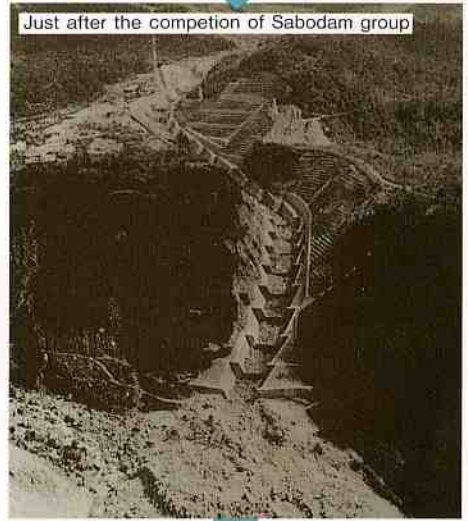
Just after the completion of Sabodam group

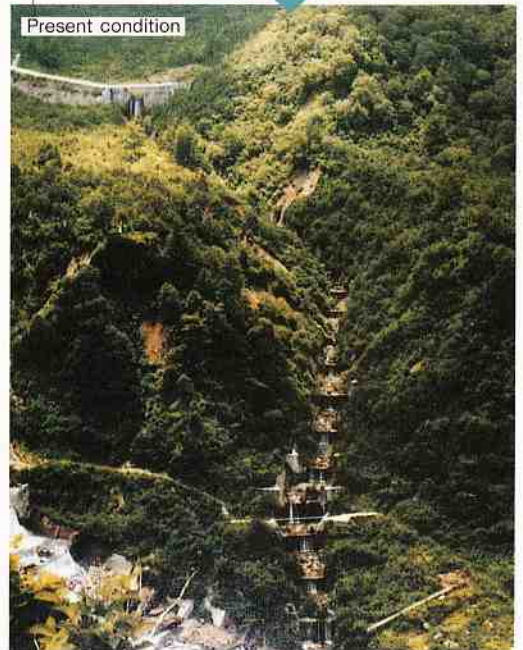
Present condition

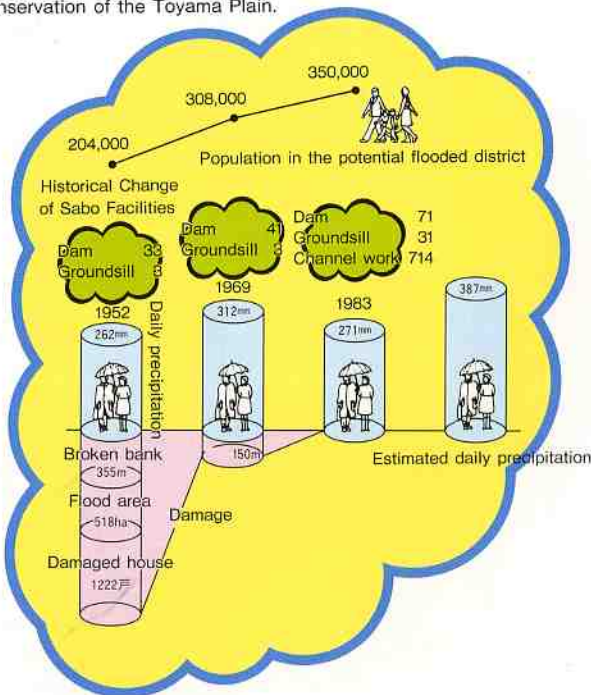
In the basin of the River Joganji where there is a high risk of disaster, the Sabo work project having continuously been executed up to now results in positive decrease of damage. In the heavy rain of 262 mm in daily precipitation recorded in 1952, the Toyama Plain was suffered from the damage mounting to 355 m long in broken banks, 518 ha in flooded area and 1,222 in damaged houses.

Thanks to the subsequent establishment and betterment of Sabo facilities, however, in the heavy rain recorded in 1969, the damage was limited only to 150 m long in broken banks, and in the local severe rain recorded in 1983, no damage such as broken banks, inundated fields and damaged houses was caused. In consideration of the recent increase in population and property in the potential flooded district, however, once a disaster occurs, it may lead to a severe damage. For this reason, it is necessary to execute the Sabo work project continuously for the purpose of preventing the outflow of sediment even in case of the estimated daily precipitation of 387 mm with the aim at much more conservation of the Toyama Plain.

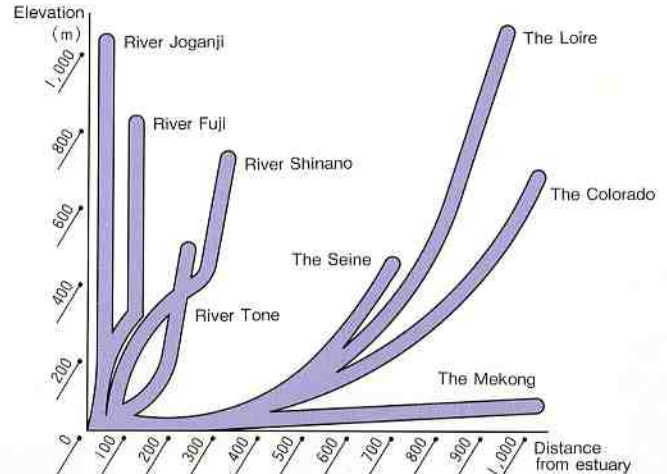
River Joganji is one of the most prominent mountain torrents in Japan 56 km long in channel, 368 km<sup>2</sup> in catchment area and 1/30 in average bed slope, and is a raised bed river causing frequent outflow of sediment.
